## Lots 122 and 123 Dacelo Vista, Waterford

### Bushfire Attack Level (BAL) Compliance Report

Prepared for  
Richard Noble  
by Strategen

March 2019

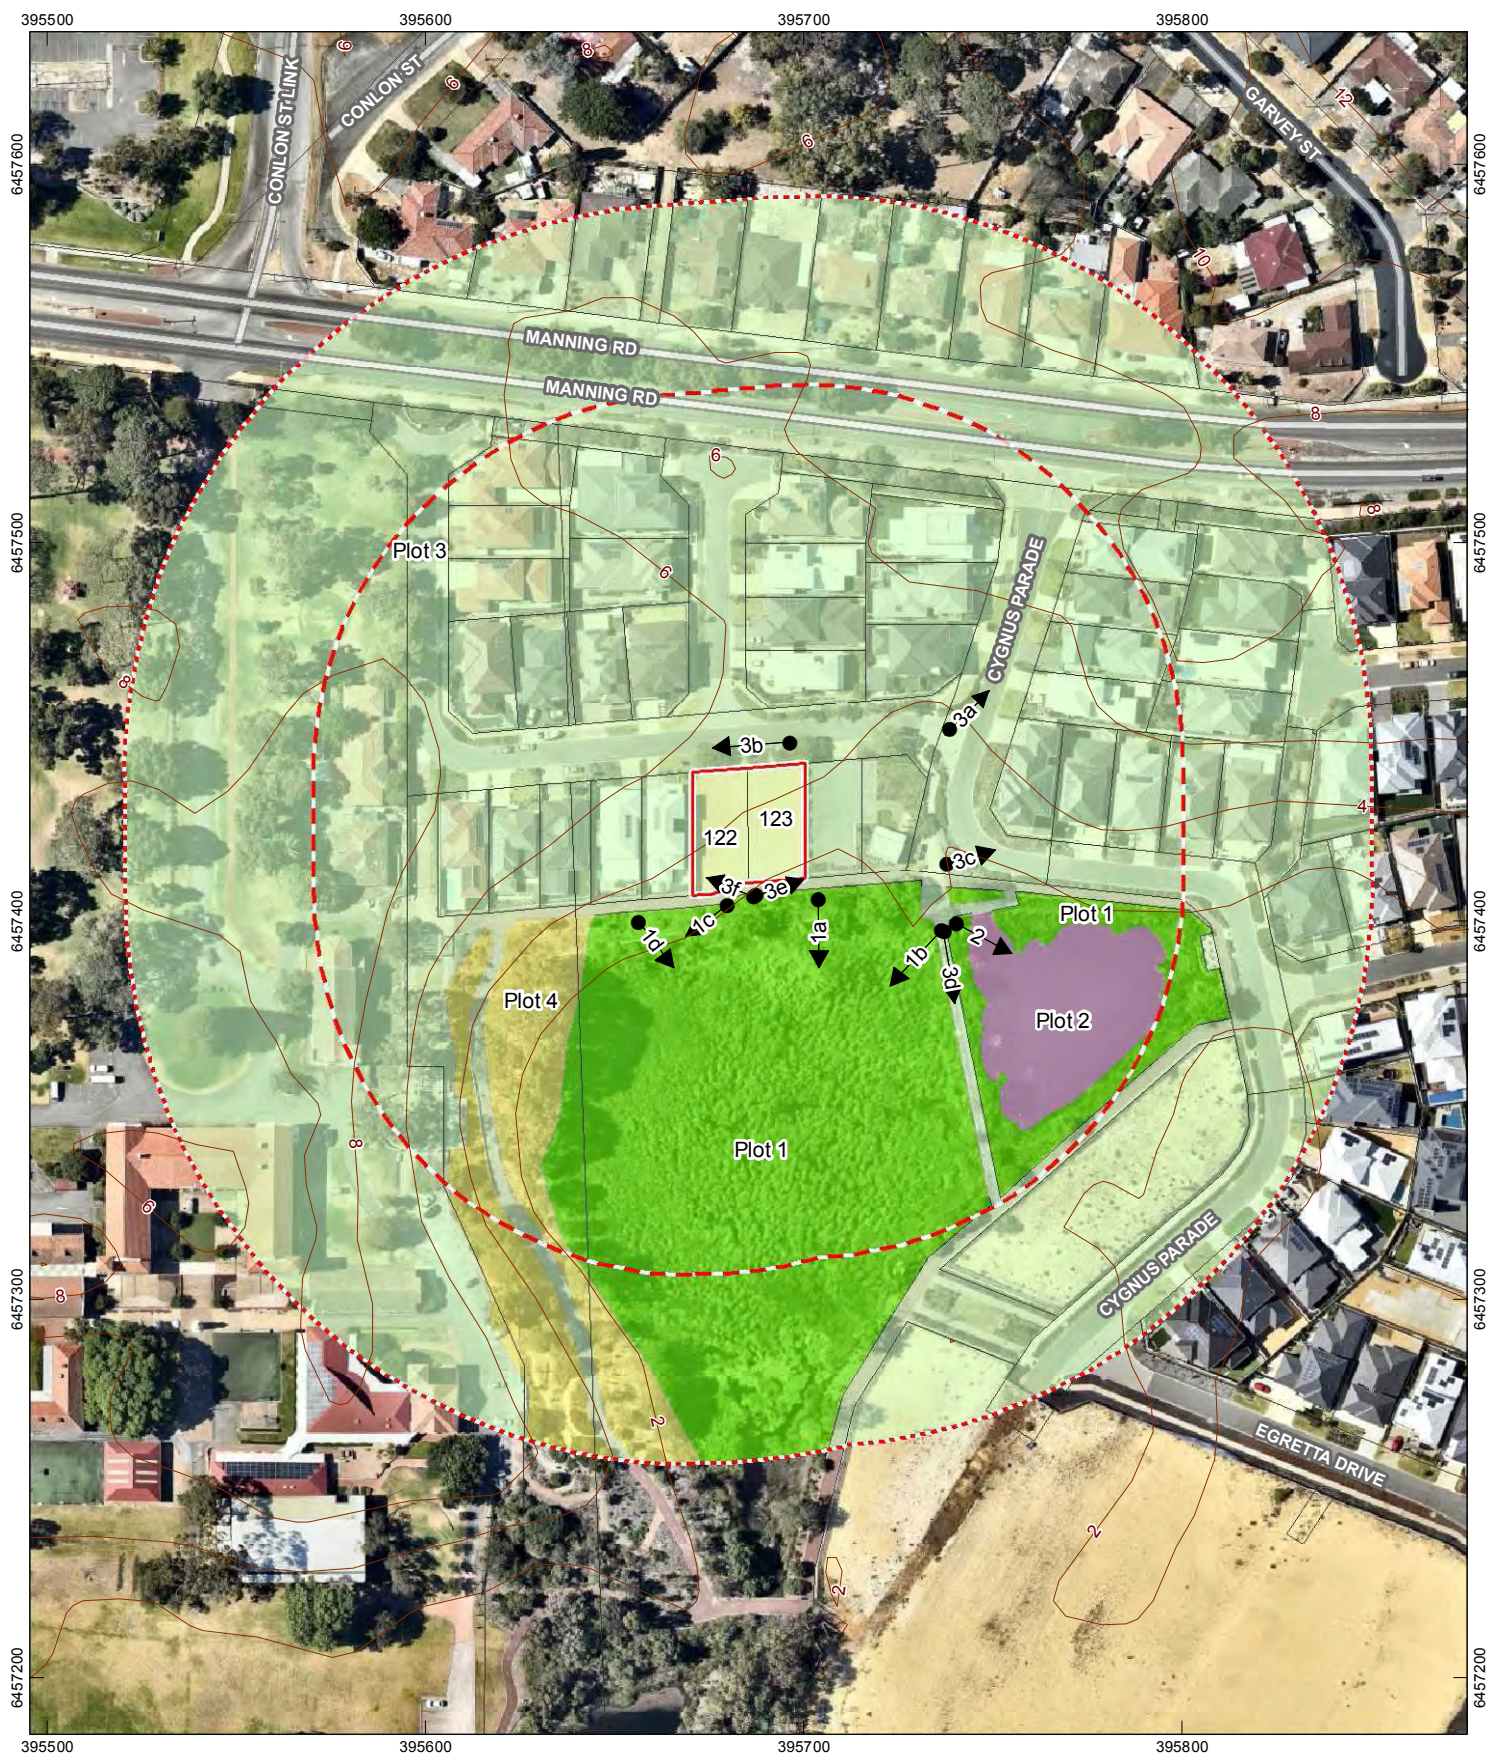
**Figure 1: Vegetation classification and effective slope**

Figure 1 illustrates the current vegetation classifications and exclusions observed during the inspection. The vegetation classifications/exclusions and effective slope are summarised in Table 2.

Vegetation plot	Vegetation classification	Effective slope	Comments
1	Class G Grassland	Flat/upslope (0°)	The wetland area is undergoing rehabilitation to remove weeds and reintroduce native grasses. The area is dominated by wetland grasses and reeds.
2	Excluded – Non-vegetated (Clause 2.2.3.2 [e])	N/A	Non-vegetated component of the wetland (i.e. standing water).
3	Excluded – Non-vegetated & Low threat (Clauses 2.2.3.2 [e] and [f])	N/A	Non-vegetated and low threat areas comprising managed gardens, managed road verges, roads, paths and built form.
4	Excluded – Low threat (Clause 2.2.3.2 [f])	N/A	Low threat managed vegetation. This area is a public open space consisting of walking paths and managed gardens. There is no vegetation in the understorey.

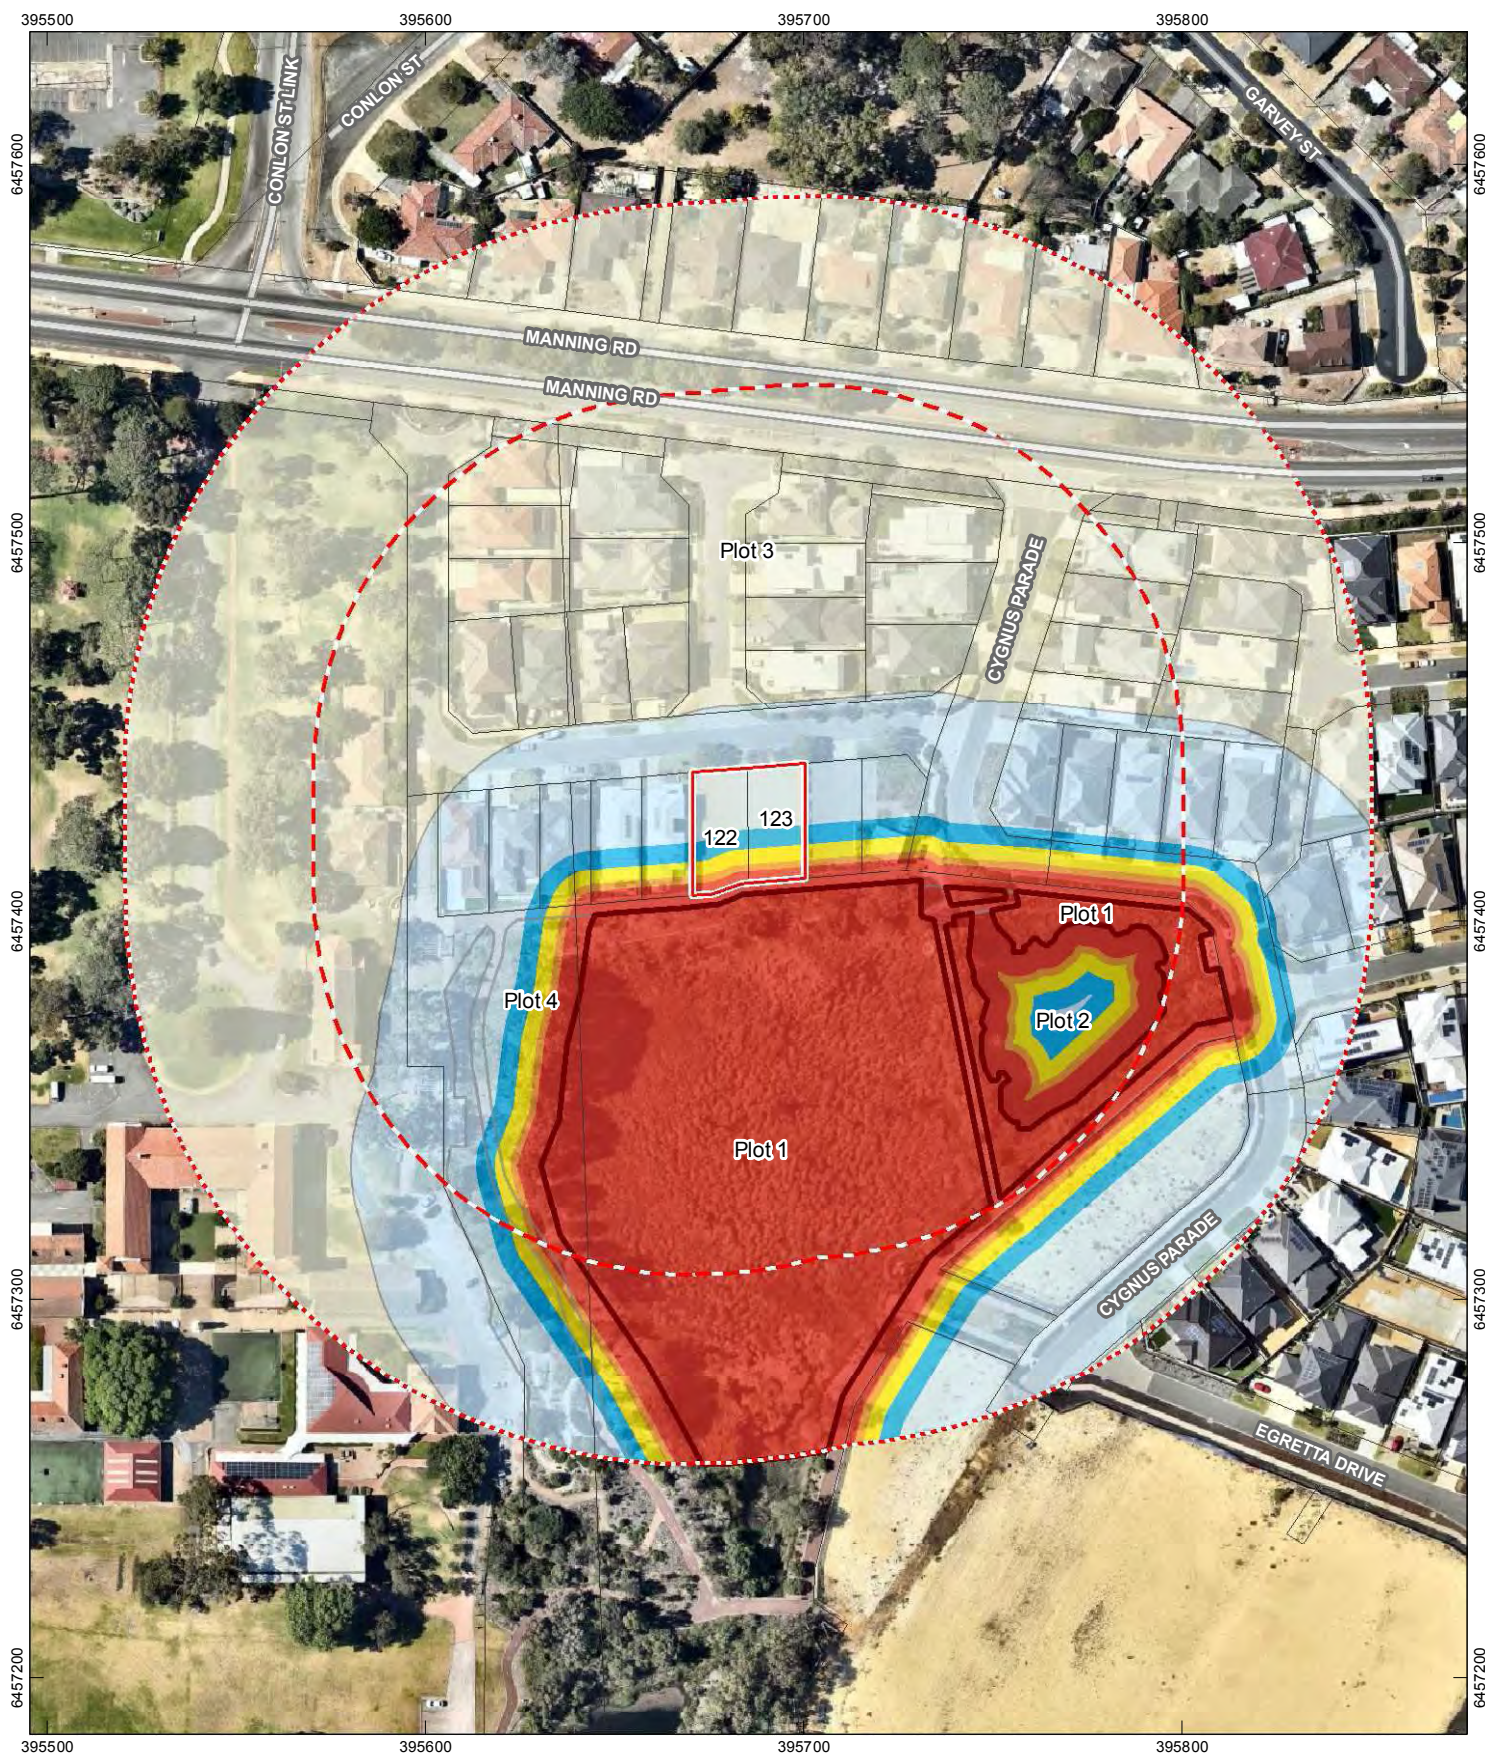
**Figure 2: BAL contour map**

The results of the BAL contour assessment are detailed in Table 3 and illustrated in Figure 2. Where applicable, Table 3 recommends building setbacks for future buildings to achieve a lower BAL rating.

Method 1 BAL determination							
Lot	Vegetation Plot	Vegetation classification	Effective slope	Separation distance	Highest BAL	Setback required to achieve lower BAL	Potential modified BAL <sup>^</sup>
122 and 123	1	Class G Grassland	Flat/upslope (0°)	3 m	BAL-FZ	5 m rear building setback	BAL-29
122 and 123	2	Excluded – Non-vegetated (Clause 2.2.3.2 [e])	N/A	N/A	N/A	N/A	N/A
122 and 123	3	Excluded – Non-vegetated & Low threat (Clauses 2.2.3.2 [e] and [f])	N/A	N/A	N/A	N/A	N/A
122 and 123	4	Excluded – Low threat (Clause 2.2.3.2 [f])	N/A	N/A	N/A	N/A	N/A

Should a lower BAL rating be realistically achievable through an appropriate building setback, then the landowner can refer to the recommended setbacks listed in Table 3. The lower BAL rating may be achieved if the recommended building setback is reflected on the building plan for that lot and a revised BAL certificate can be issued at that time.

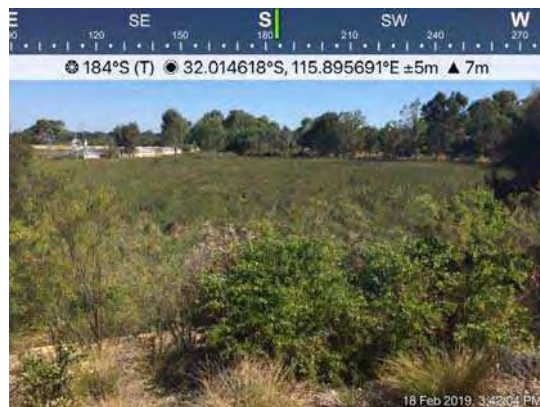
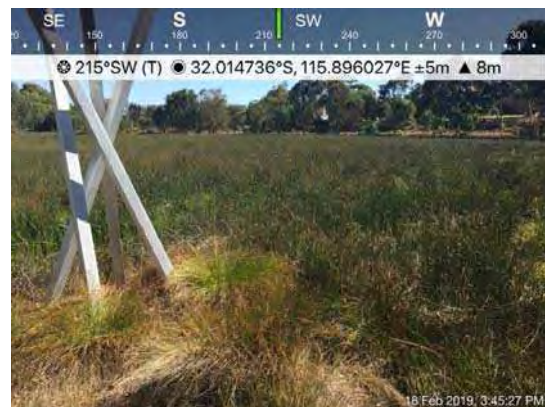
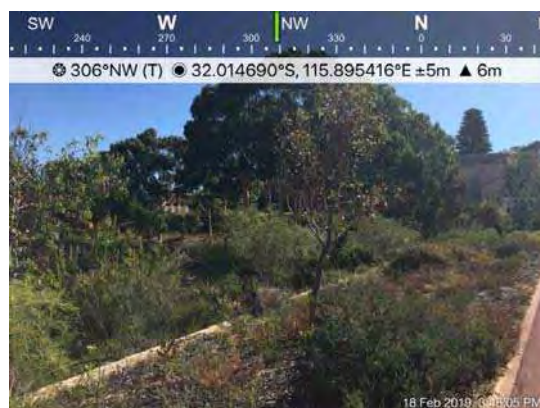
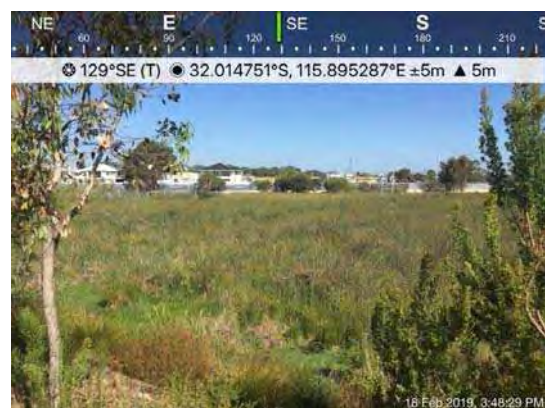
Plot number		Plot 1
Vegetation classification	Pre-development	Class G Grassland
	Post-development	Class G Grassland
Description / justification		Wetland area undergoing rehabilitation to remove weeds and reintroduce native grasses. The area is dominated by wetland grasses and reeds.

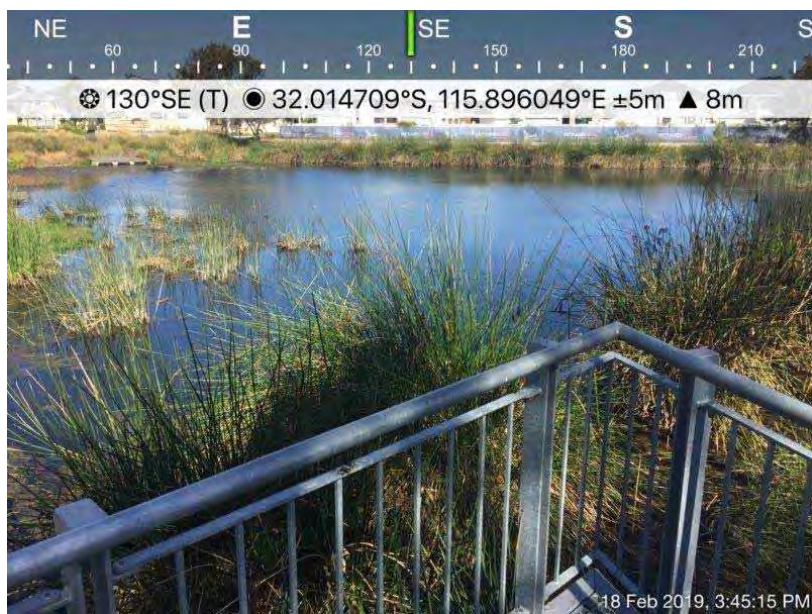
Photo ID: 2

<b>Plot number</b>		Plot 2
<b>Vegetation classification</b>	<b>Pre-development</b>	Excluded – Non-vegetated (Clause 2.2.3.2 [e])
	<b>Post-development</b>	Excluded – Non-vegetated (Clause 2.2.3.2 [e])
<b>Description / justification</b>		Non-vegetated portion of the wetland (i.e. standing water).

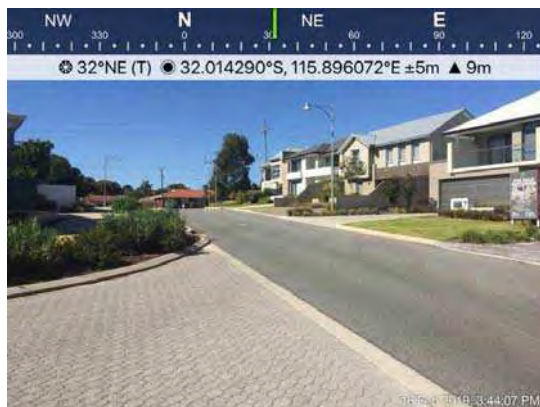
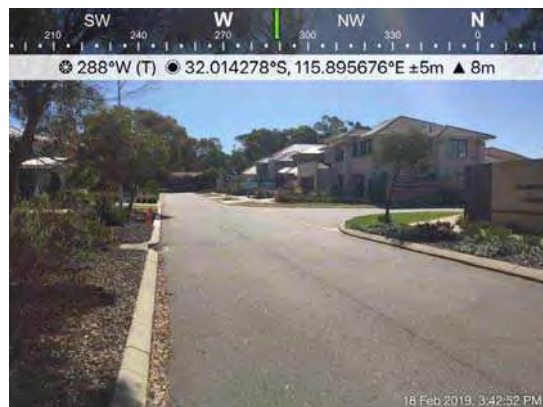
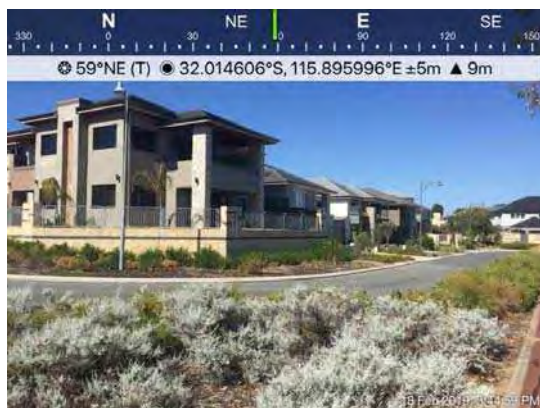
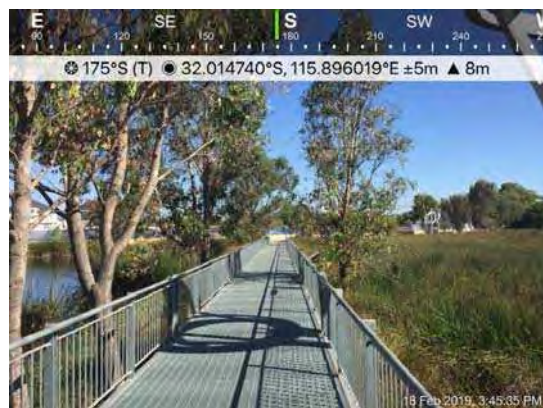
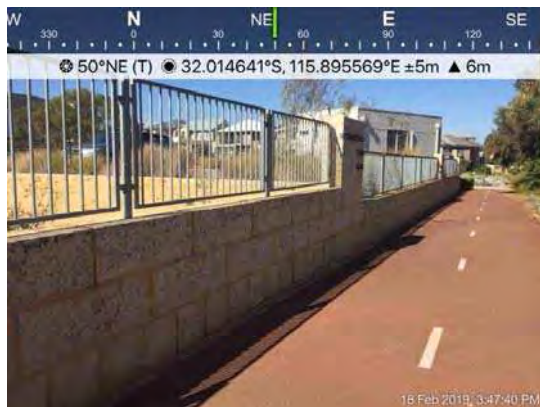
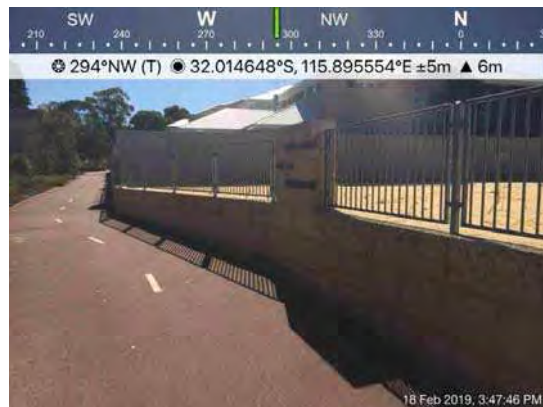
Plot number		Plot 3
Vegetation classification	Pre-development	Excluded – Non-vegetated & Low threat (Clauses 2.2.3.2 [e] and [f])
	Post-development	Excluded – Non-vegetated & Low threat (Clauses 2.2.3.2 [e] and [f])
Description / justification		Low threat and non-vegetated areas comprising managed gardens, managed road verges, footpaths, road and built form.
