**DUST AND ASBESTOS  
MANAGEMENT PLAN  
CYGNIA COVE, WATERFORD**

Report Date: 5 November 2009  
Project Ref: 2006/225, V9

**RE: DUST AND ASBESTOS MANAGEMENT PLAN - CYGNIA COVE, WATERFORD**

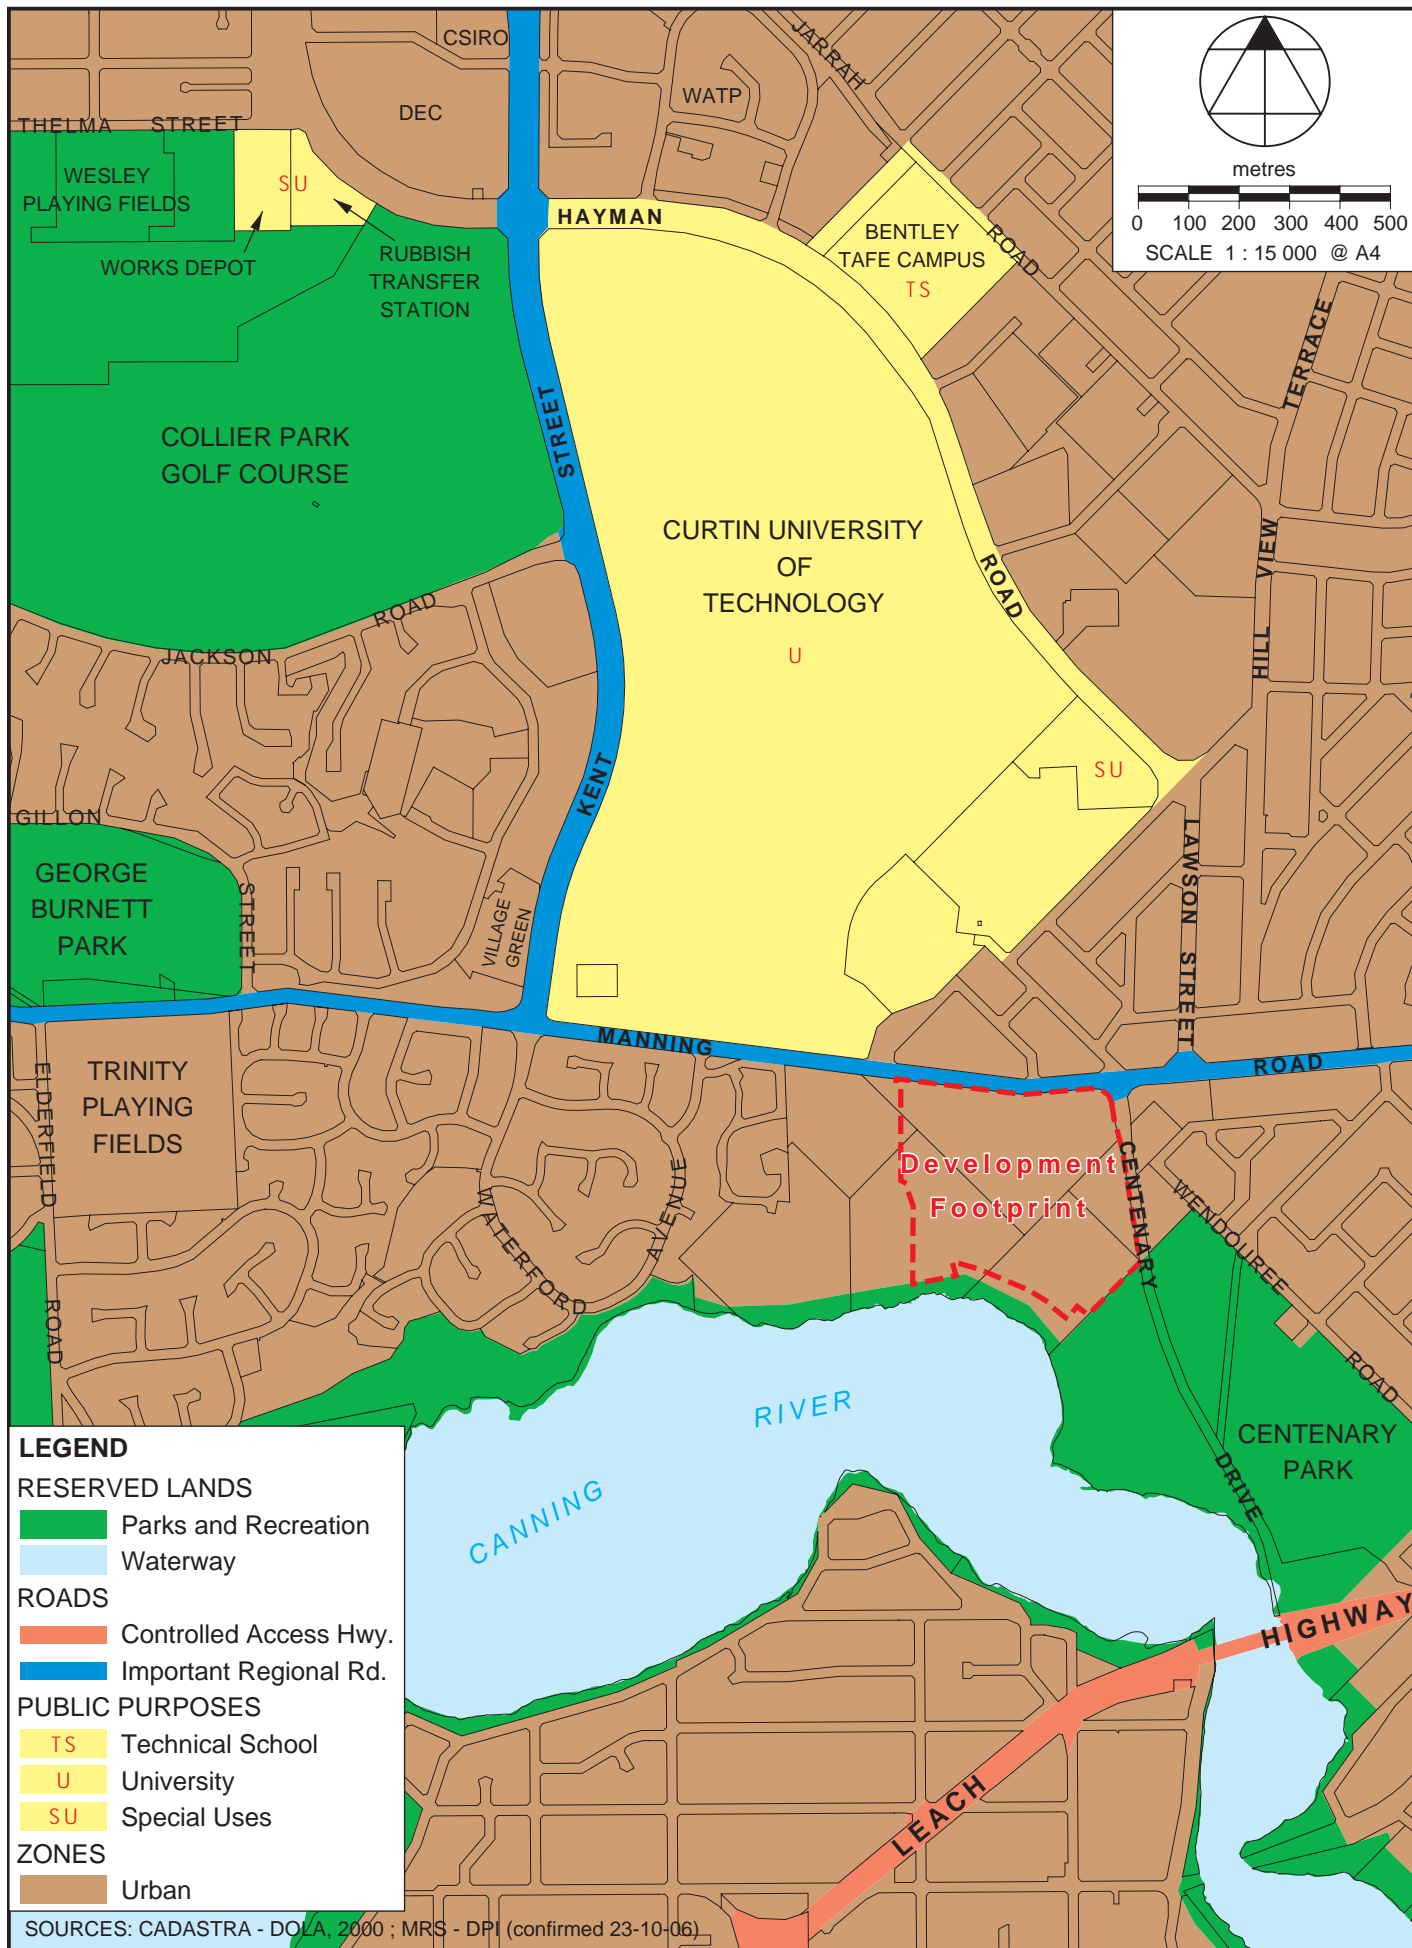
FIGURE 2

DUST AND ASBESTOS MANAGEMENT PLAN  
CYGNIA COVE, WATERFORD  
**SURROUNDING LAND USE**

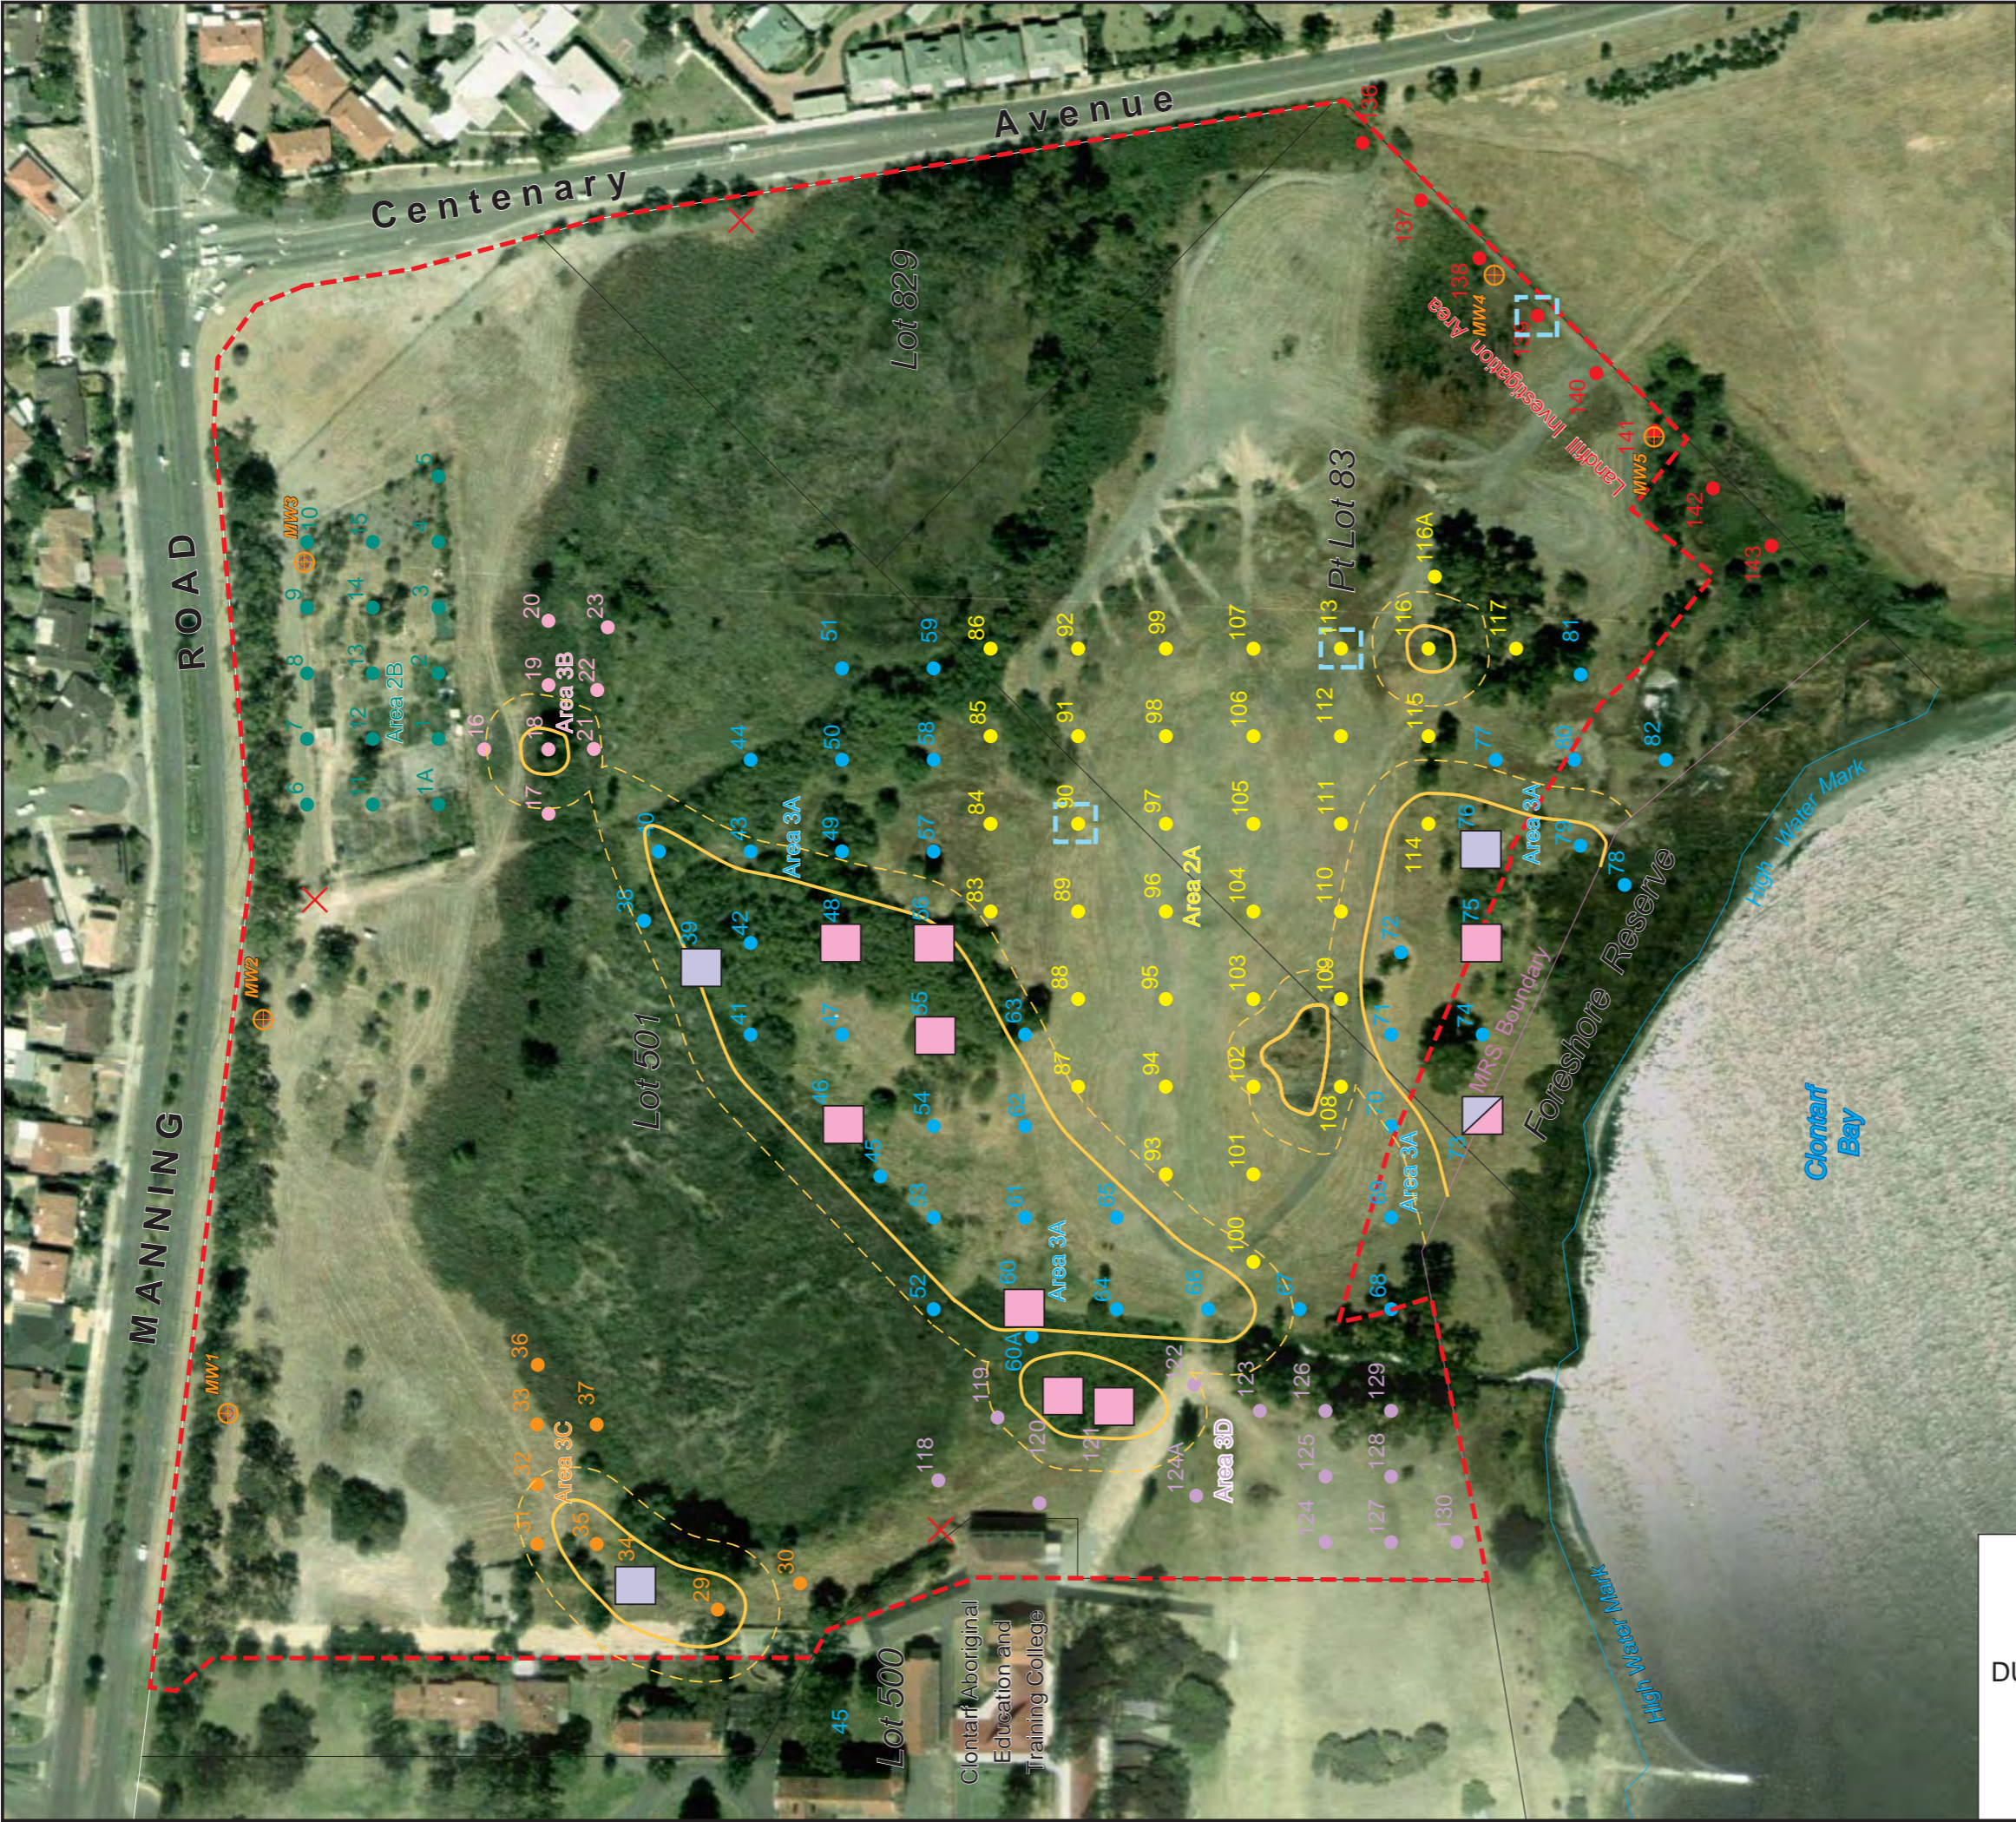
**DUST AND ASBESTOS MANAGEMENT PLAN**  
**CYGNIA COVE, WATERFORD**  
**REMEDIATION AREAS**  
**FIGURE 6**

- Development Footprint Boundary (dashed red line)
- Cadastral Boundary (solid black line)
- Monitoring Well Location (orange circle with crosshair)
- Indicative Location of Permanent Air Monitoring Station (red 'X')
- Soil Sample Location (colour indicates Area) (numbered orange dots)
- Areas of Uncontrolled Fill (yellow dashed outline)
- Surface Soil Removal Buffer Zone (yellow solid outline)
- Asbestos fibers detected: Proposed remediation area (pink square)
- Analytical concentration of Chromium > EIL in natural sandy clay (blue dashed outline)
- Analytical concentration > EIL in soil profile: Proposed remediation area (pink square)

5. In the instance of surface soil removal which has been recommended to be conducted in a radius extending 10m from all areas identified as containing uncontrolled fill (Figure 6), the soil will be loaded directly into tip trucks for off-site disposal.

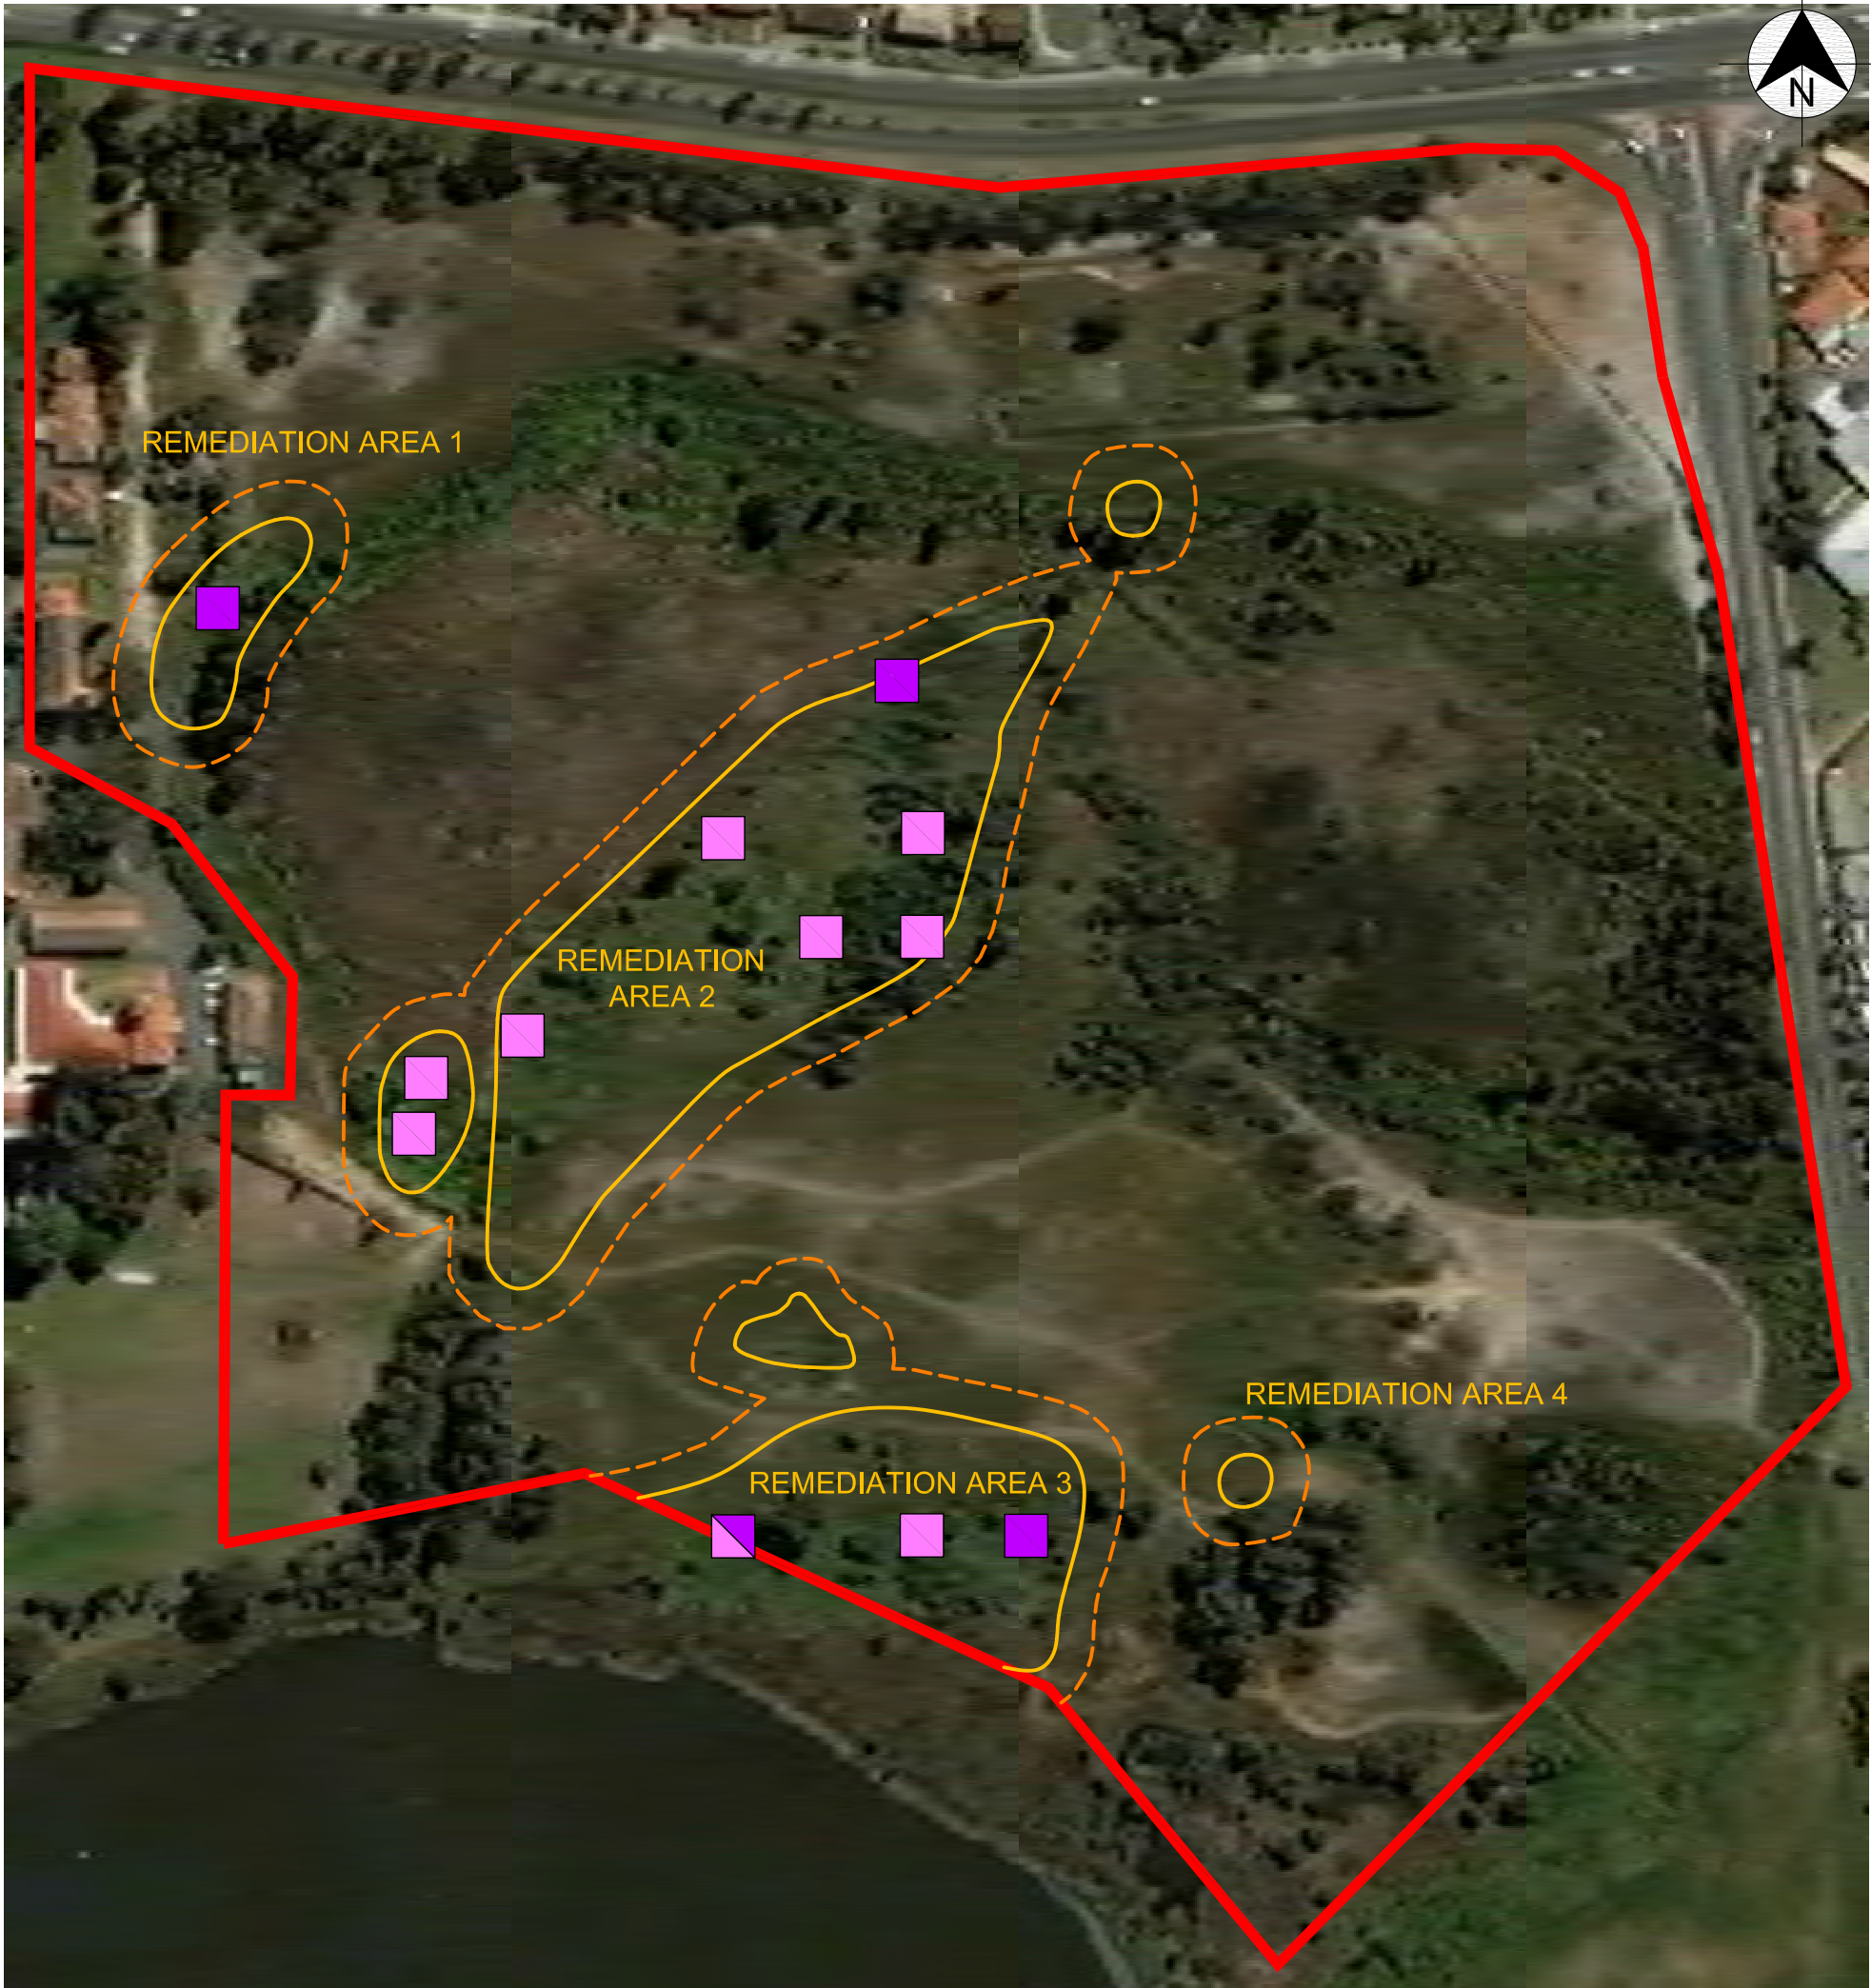
- Development Footprint Boundary
- Areas of Uncontrolled Fill
- Surface Soil Removal Buffer Zone
- Asbestos fibres detected: Proposed remediation area
- Analytical concentration > EIL in soil profile: Proposed remediation area

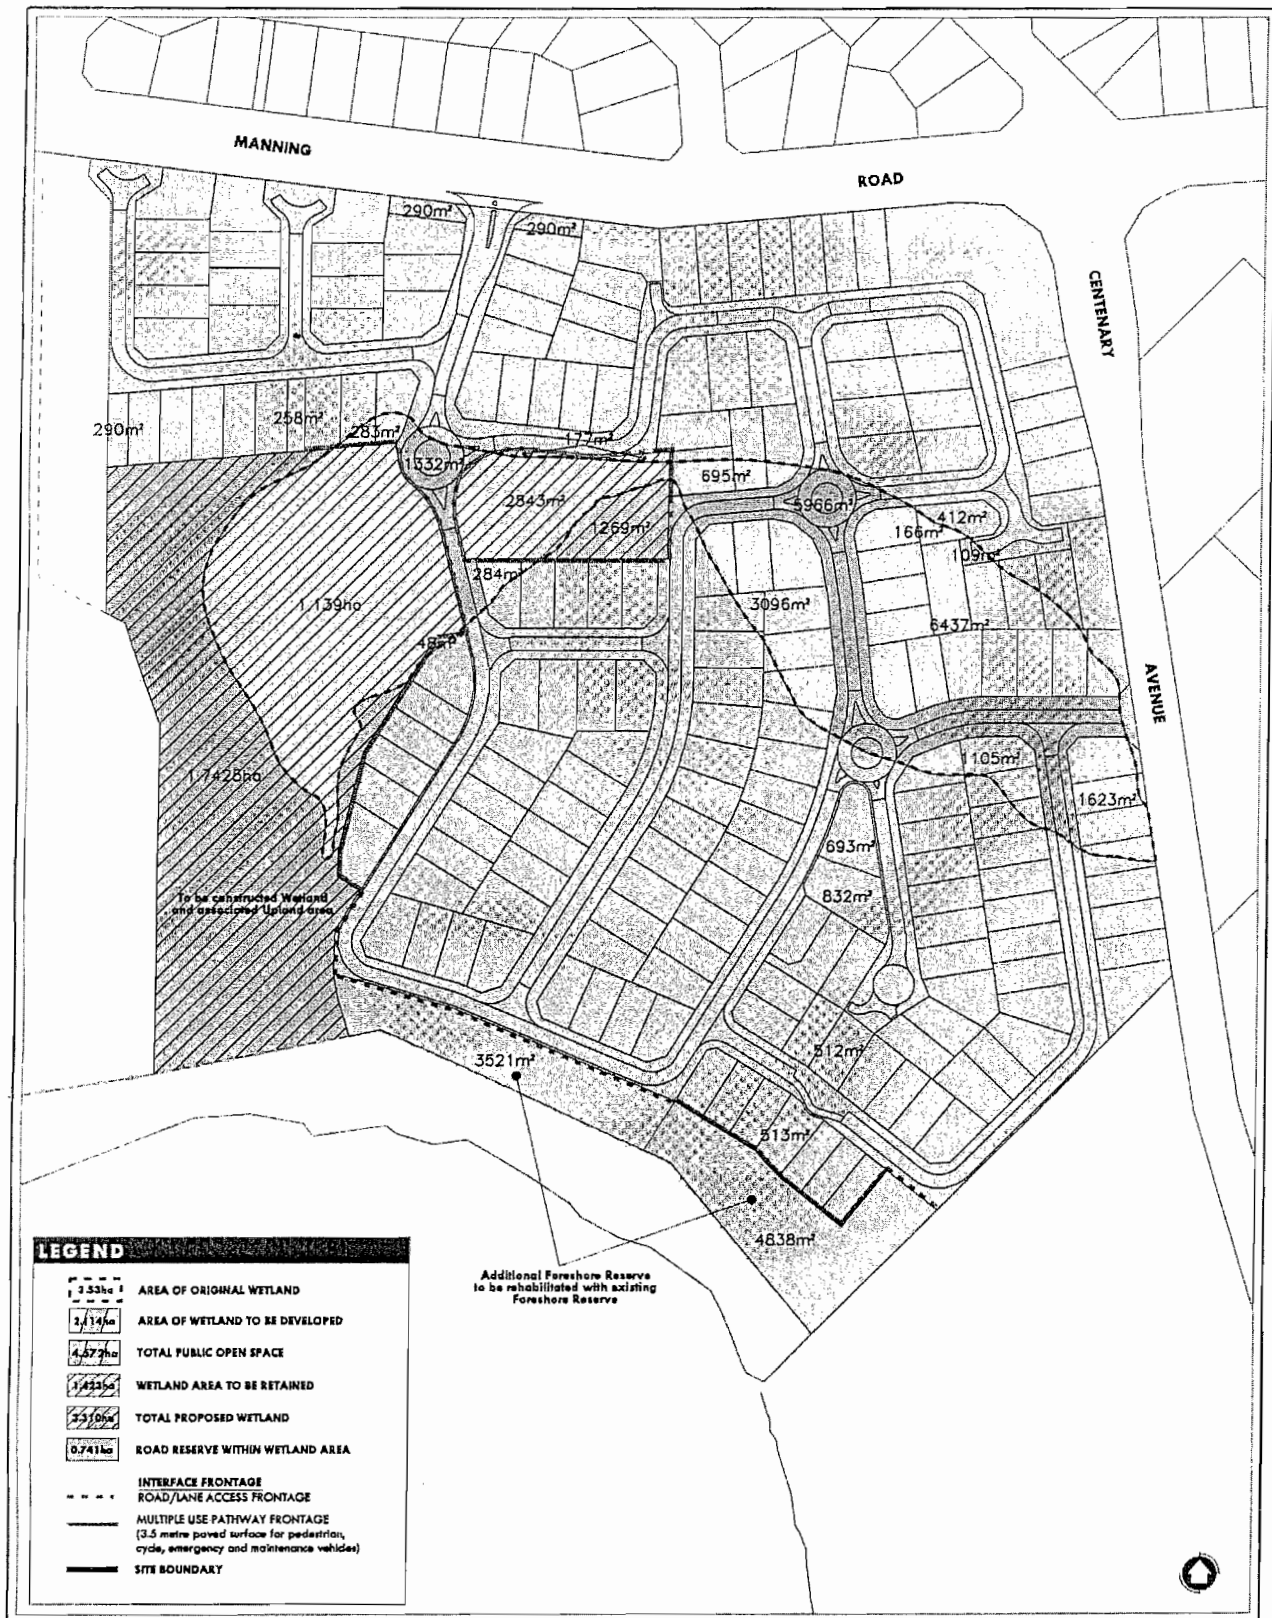
**Figure 1 - Residential Development Plan**

Note: The area for residential development is within the "site boundary", but excludes "Public Open Space", the "Wetland Area", and the "Area of Proposed Rehabilitated Wetland" indicated above.

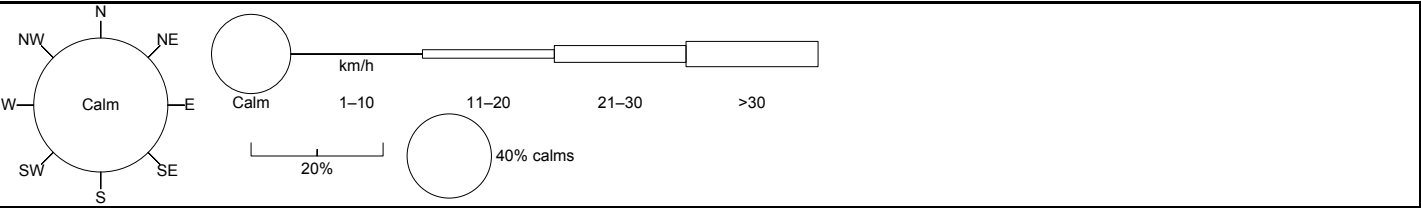
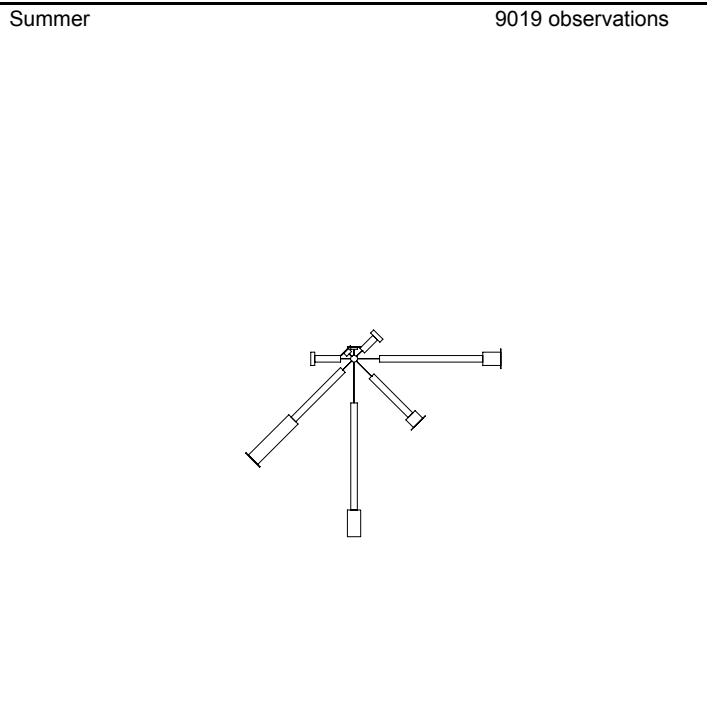
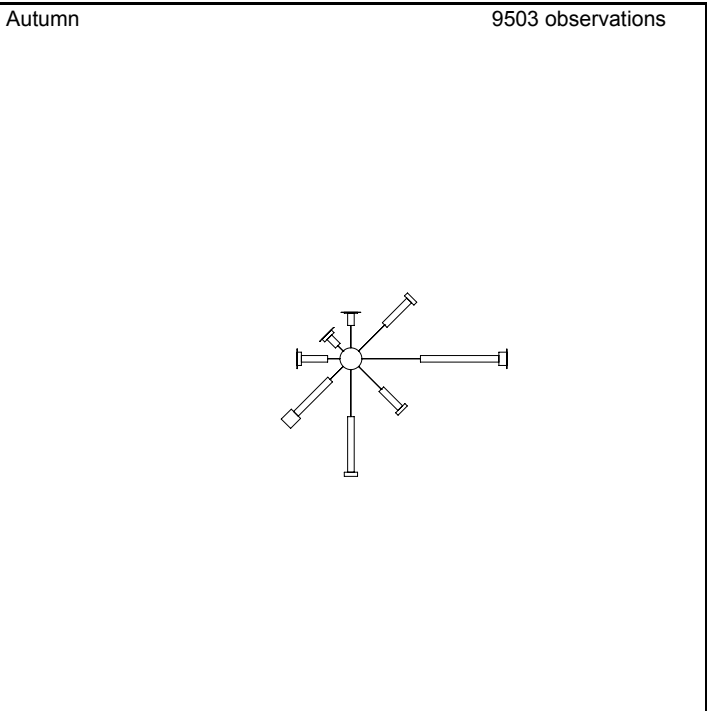
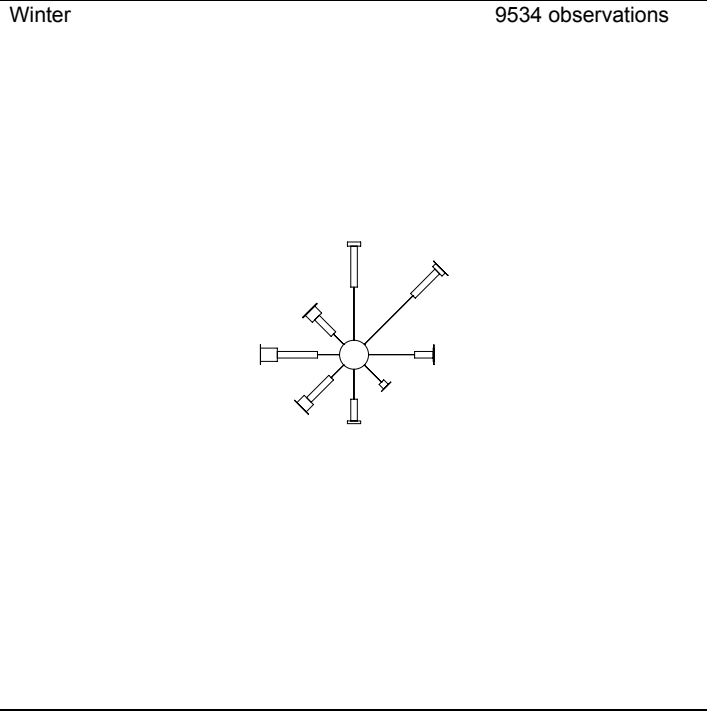
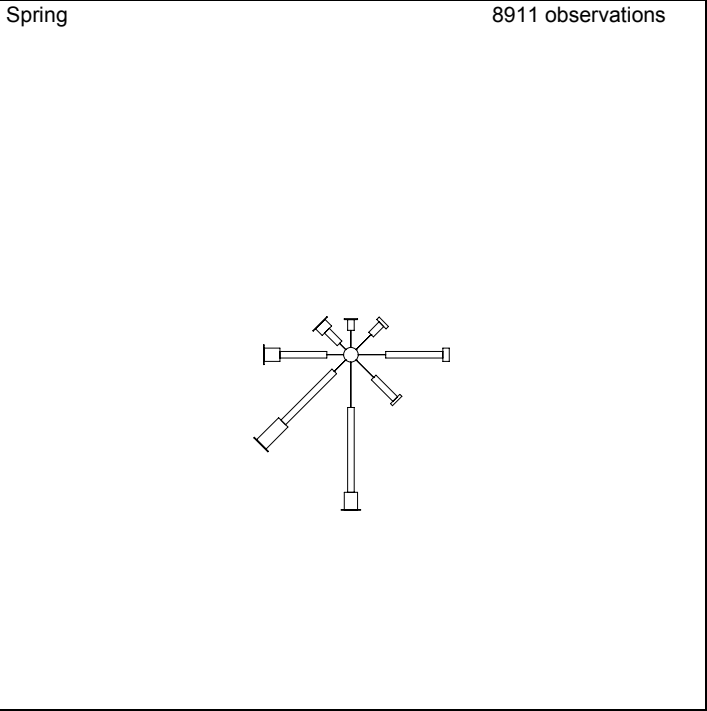
# Wind Frequency Analyses and Wind Roses

The included set of wind frequency analysis tables or wind roses show the frequency with which winds of various strengths have been observed coming from various directions. These notes should help you to use the information.
